**BLACKSTONE RIVER BASIN
MILLBURY, MASSACHUSETTS**

**BRIERLY POND DAM
MA 00143**

PHASE I INSPECTION REPORT NATIONAL DAM INSPECTION PROGRAM

OCTOBER 1978

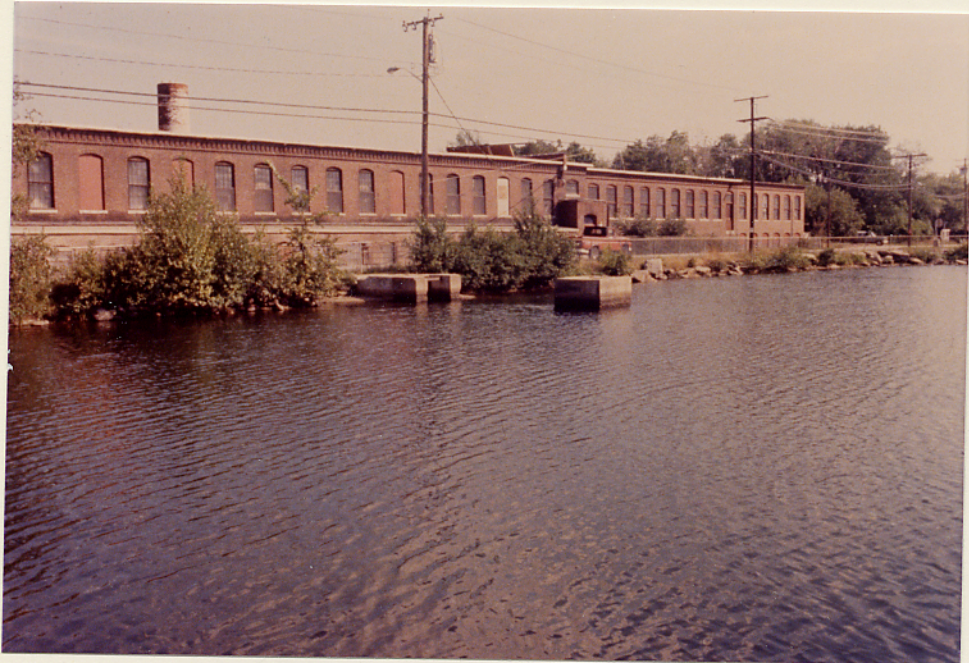
UPSTREAM VIEW OF MAIN DAM

- b. Dam. The earthfill dam, which forms part of West Main Street, is in generally good condition. The paved crest is level with no cracks or depressions on the surface. The upstream slope is covered with weeds and only partially protected by scattered riprap 1.5 to 2.5 feet in size. Apparently there was once a short vertical stone wall at the top of the slope but the wall has deteriorated in places to a pile of rubble at the toe. The three-story brick building situated on the downstream slope of the dam is separated from the road by a 4-foot-wide, 10-foot-deep concrete channel. This channel is partially filled with water.

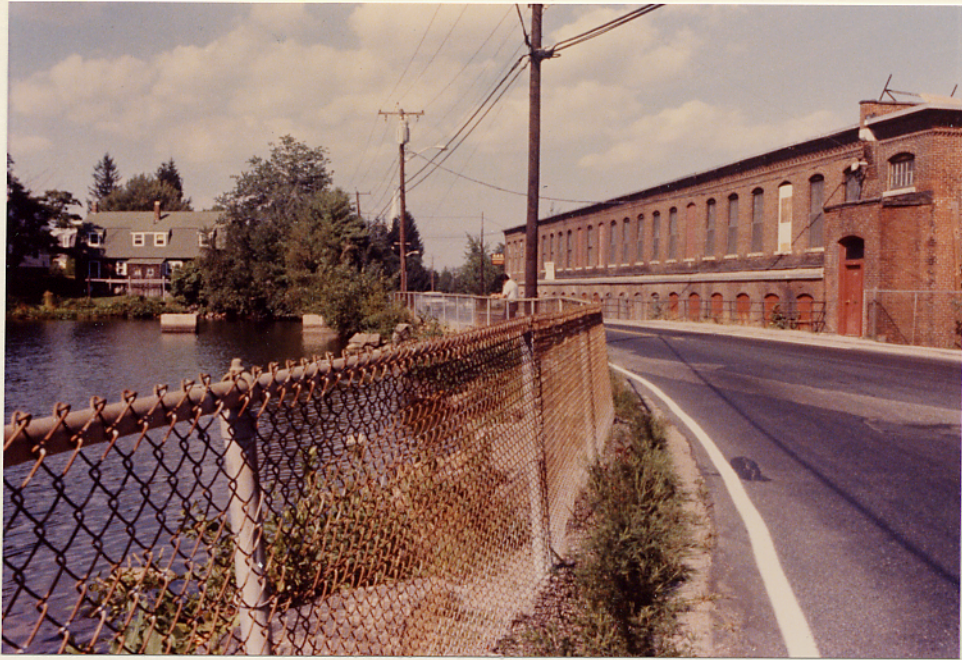
NO. 1 CREST OF DAM

- 4.2 Maintenance of Dam. The crest of the main dam is a paved town road and is maintained by highway department personnel. The upstream slope of the dam has deteriorated, judging by the condition of the stone wall on the upstream face and the accumulation of debris and vegetation. The dike crest and downstream slope appear to be maintained by the residents of the abutting property, but the upstream face is overgrown with brush.

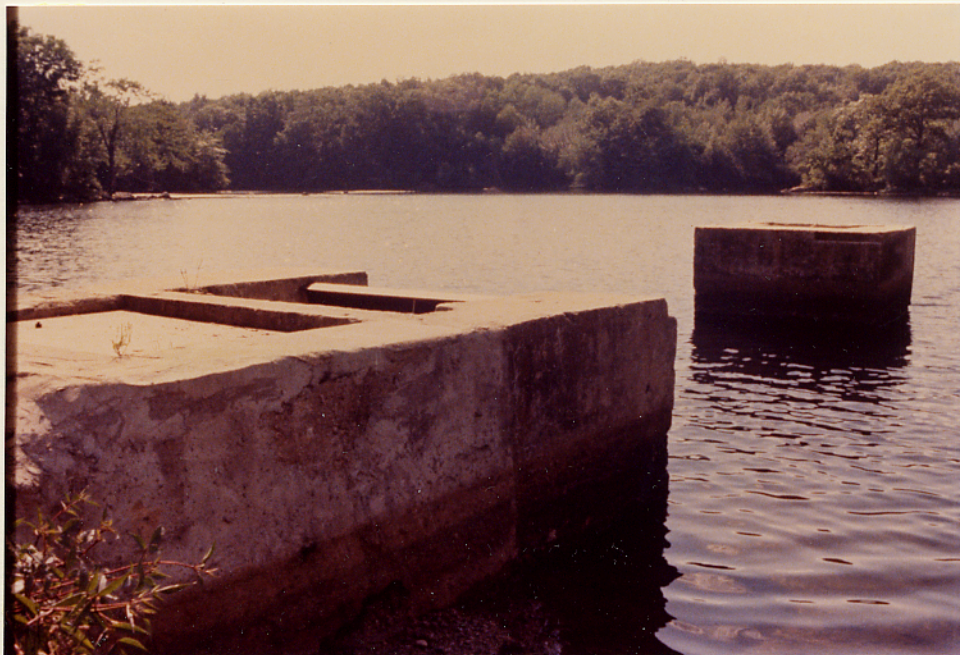
NO. 2 OUTLETS B AND C AT DAM

Outlet B at the main dam is in fair condition. The concrete is spalling, especially at the water line. The slide gate is closed, and there is no permanent gate-opening mechanism in place. Water can be heard running inside the structure, suggesting that the gate leaks.

- 4.3 Maintenance of Operating Facilities. The service intake structure C at the main dam was blocked with concrete by the Owner. The gate on the low-level outlet B appears to be leaking. Apparently the Owner has not used it for about 3 years, as there is no permanent operating mechanism. There is no known maintenance procedure for Outlet A.

- a. Operating and Maintenance Procedures. The dam and appurtenance structures are not adequately maintained. It is recommended that the Owner accomplish the following:
- (1) construct a permanent operating mechanism for opening the gate on the low-level outlet at the dam (Outlet B).
 - (2) repair the leak through the gate, and the spalled concrete at Outlet B.
 - (3) repair the riprap and erosion on the upstream face of the dam and clear the vegetation.
 - (4) repair the stone walls in the approach channel, and the railing on the walkway at Outlet A.
 - (5) clear the trees and vegetation on the dike and along the outlet channel.
 - (6) implement a systematic program of maintenance inspections. As a minimum, the program should consist of a monthly inspection of the dam and appurtenances,

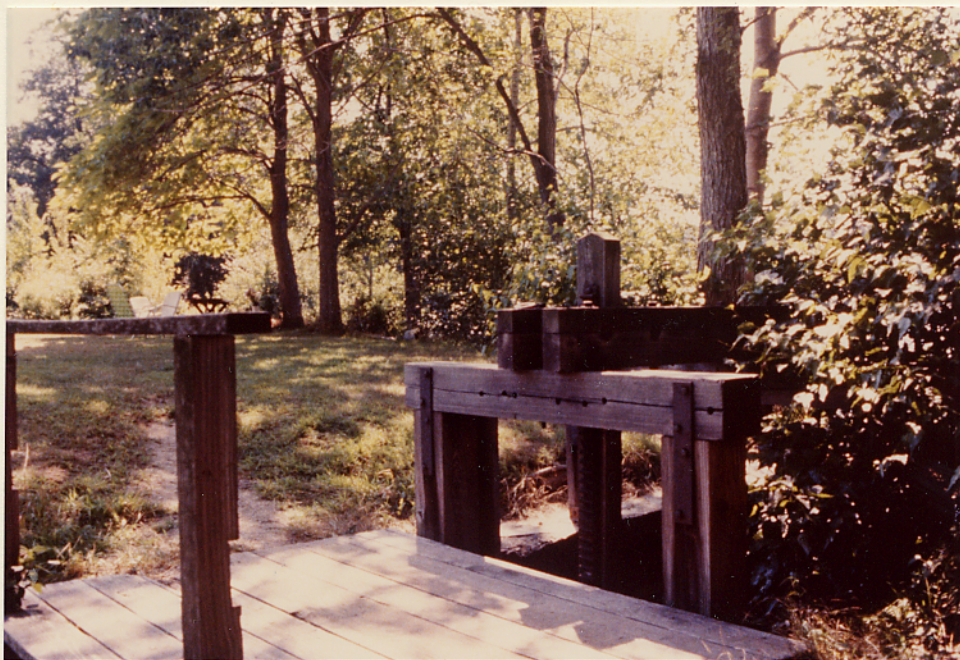
NO. 3 SLIDE GATE MECHANISM AND SOUTH END OF DIKE

The earth dike, which is located about 600 feet from the main dam, is in good condition. The crest and the downstream face are covered with grass. Since the downstream slope serves as a back yard for two residences, the area is very well maintained. There are trees and shrubs growing on the upstream side of the crest, partially hiding the low stone wall on the shore.

There is minor spalling and erosion of concrete in the vicinity of the gate, but the gate appears to be in good condition. It is operable by a rack and pinion mechanism hung between timbers. The mechanism is accessible by means of a wooden walkway which crosses the outlet channel. The railing on the walkway is very loose. There is a keyway for flashboards to be added above the gate, but the flashboards had been removed that week by the Owner.

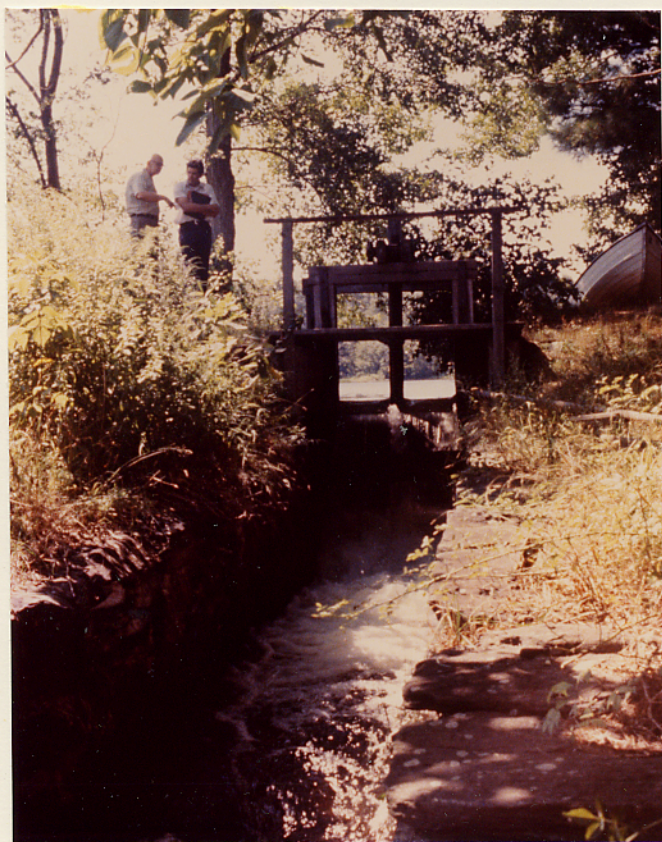
NO. 4 OUTLET CHANNEL (OUTLET A)

The stone masonry of the narrow outlet channel is in good to fair condition; some of the mortar and a few stones are missing at the base of the sidewalls. There are numerous trees growing on the banks of the channel, and in some places it is completely hidden by brush. The open channel ends at West Main Street and the inlet to the stone box culvert is obscured by vegetation. The outlet downstream of the street is in a stone masonry retaining wall. This area near the road is completely overgrown with trees.
